# **UPPER HUNTER SHIRE COUNCIL**

## **SCONE AERODROME SAFETY INSPECTION**

## **AERODROME SAFETY INSPECTION**

**6 and 7 February 2019**

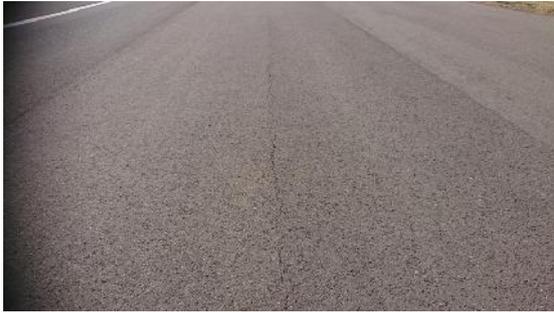
There are many joints within the asphalt section that have now opened up due to shrinkage, and a number of cracks have appeared on the edges of the pavement, some have had weeds growing in them.

Photo 1 – Typical open joint on Runway 11/29

The cracking in the pavement is now so extensive that it is unlikely that a crack sealing program will rectify the problems and provide a water proof surface. The larger cracks should be sealed to prevent the ends fretting off and producing FOD and any vegetation growing in the cracks should be removed.

- Recommendation 1** *The Kamen Engineering report “Pavement Investigation, Assessment, Maintenance and Rehabilitation Scone Regional Airport”, dated 22 December 2017, should be implemented as soon as possible.*
- Recommendation 2** *If it not possible to implement the Kamen Engineering report within 12 months, another solution should be developed with appropriate engineering advice to protect the pavement. One such treatment could be a 10 mm bitumen seal over the asphalt section of the runway.*
- Recommendation 3** *Seal all the large cracks to prevent the edges fretting and producing FOD penetrating into the pavement.*

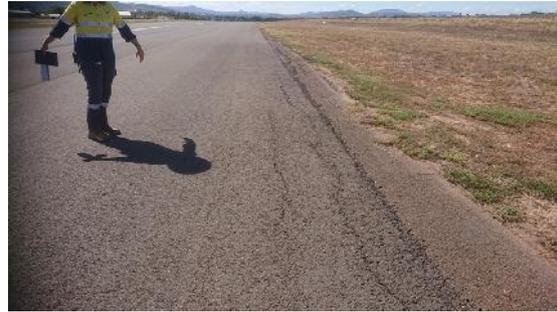
Photo 2 – SW edge showing cracking

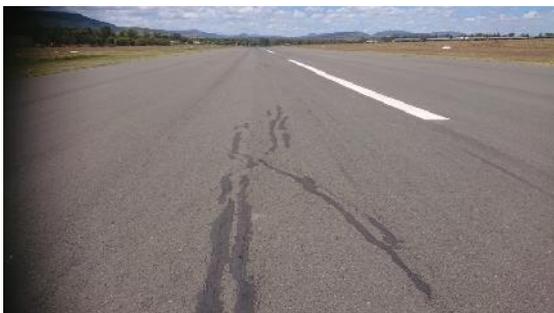
Photo 3 – Runway 11/29 crack patching

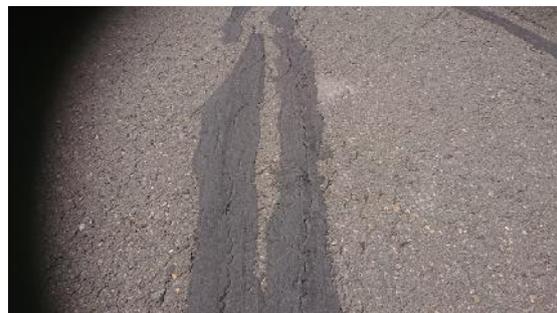
Approximately 500 m from the 29 Threshold there are a number of areas where the surface has been pushed up about 20 to 30 mm over an area with about a 5 m diameter; these bulges are known locally as gilgis. It is most likely that these gilgis have formed when water has entered the expansive underlying clay which has swollen, pushing the pavement up. At each gilgi site there is either a pavement crack or an open joint "upstream" of the swelling where water may have entered the pavement. As the sub-surface is a granular material with a high clay content it would not provide any protection against water penetration or clay expanding.

Photo 4 – Crack patching with extending cracks at the edge of a gilgi about 500 m from the Runway 29 threshold

This indicates that the pavement material is at the end of its serviceable life and has deteriorated so that it cannot be relied upon to provide a serviceable pavement into the future. The pavement should either be replaced or strengthened by lime stabilisation, and the runway should be resurfaced with asphalt to provide a water proof wearing layer.

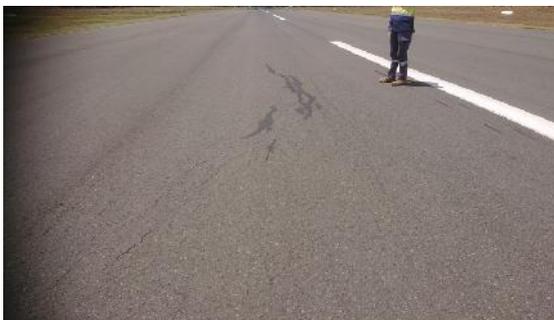
Photo 5 – Typical Runway 11/29 gilgi

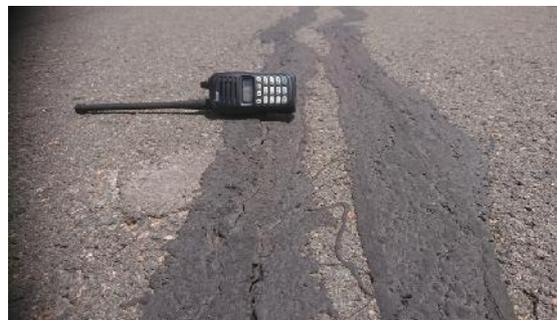
Photo 6 - Runway 11/29 edge of a gilgi

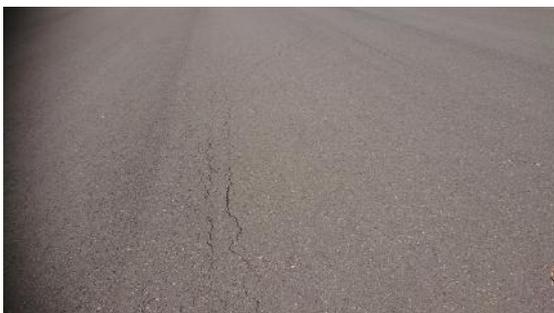
Photo 7 - Runway 11/29 pavement cracking around the edge of a gilgi

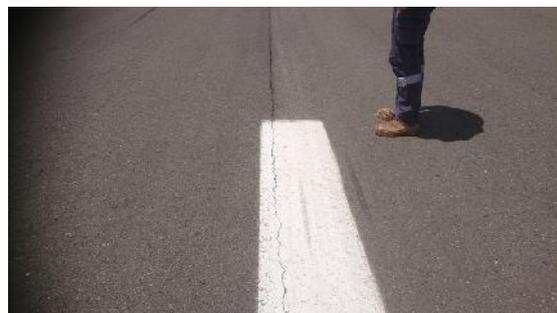
Photo 8 - Runway 11/29 centreline cracking

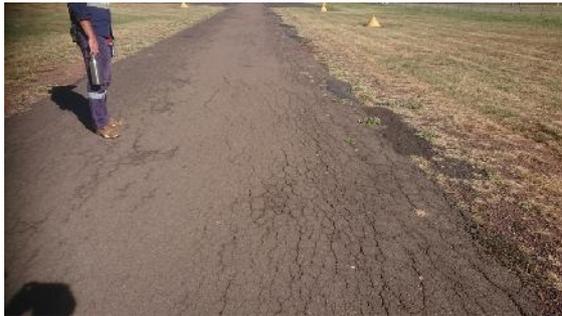
The seal surface is now severely cracked, with areas of total failure of the seal exposing the sub-grade pavement. The surface of these failed areas (each of about 1 m diameter) consisted of loose aggregate and crumbly bitumen, indicating severely

aged and oxidised bitumen. The failures have occurred through overloading an aged pavement.

Photo 9 – Pays taxiway  
Note extensive cracking of oxidised/aged bitumen seal surface

This taxiway should be repaired by resealing, or by sweeping and close monitoring. If the original pavement was a gravel pavement an effective solution would be to remove the seal surface and revert to a gravel taxiway. This will, however, increase the maintenance requirement, especially as it appears to be used more as a roadway than as a taxiway.

**Recommendation 4** *Ensure that the taxiway from the main apron to the grass parking areas and Pays Aviation is maintained in a serviceable condition, or close it.*

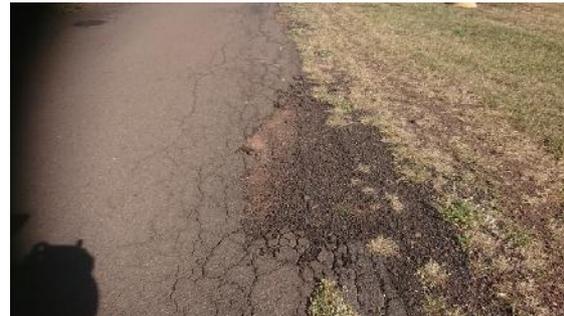
As it was found, the pavement is not safe for aircraft due to the loose stones which might cause damage to propellers. Furthermore, if there is significant rain it will weaken the subgrade and cause pot holes to form.

Photo 10 – Typical failed area on the edge of Pays taxiway

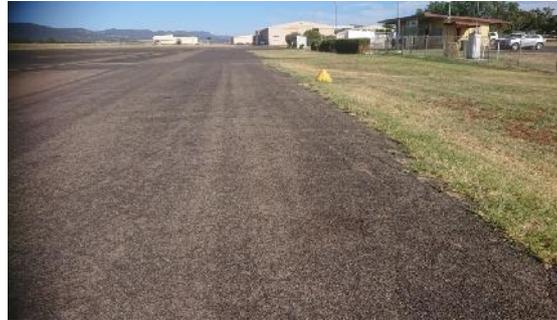
The sealed RPT apron area in front of the Terminal Building and the other parking areas in front of the hangars and to the west of the RPT were in reasonable condition except for cracking around the edges of the pavement. This is probably a result of the drought and shrinkage of the sub-grade. There are also areas of shape loss, probably due to overloading from time to time.

Photo 11 – Edge of the main apron pavement

**Recommendation 5** *Implement the Master Plan re-development or the Kamen Engineering report recommendations within the next 12 months. In the interim, maintain the pavement with crack sealing and failure repairs as required.*

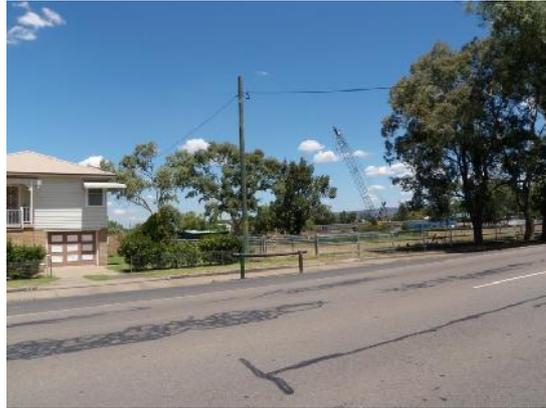
There was no information available on the cranes and they had not been assessed to determine if they have any affect on aircraft operations. It was noted that they appear to be about the same height as the trees at the eastern end of the runway. However, one of these trees have been identified by survey as an obstacle in the approach surface and needs to be lopped or removed.

The crane on the centreline might infringe the approach surface and the VSS and should be investigated to determine if it is an obstacle. If it is an obstacle it should be referred to CASA and Airservices Australia for approval, and to determine any required mitigation measures.

Photo 12 – Crane at By-pass road Kingdon Pond Bridge construction site

**Recommendation 9** *Obtain the details on the cranes being used on the bridge construction site and determine their effect, if any, on aircraft operations. Also, the information should be provided to Airservices Australia to determine any effect on the published non-precision instrument procedures.*
