UPPER HUNTER SHIRE COUNCIL

SCONE AERODROME SAFETY INSPECTION

FEBRUARY 2016

AIRPORTS PLUS PTY LTD

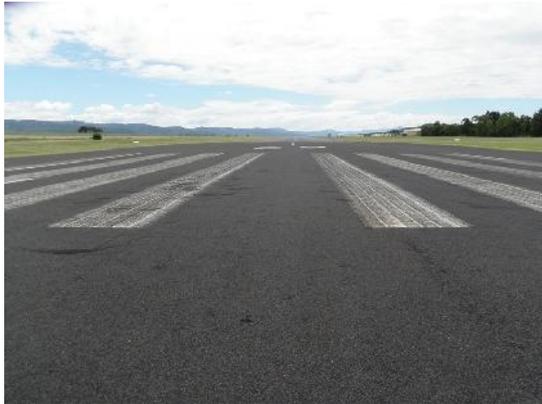
Photo 1 - General view of Runway 29

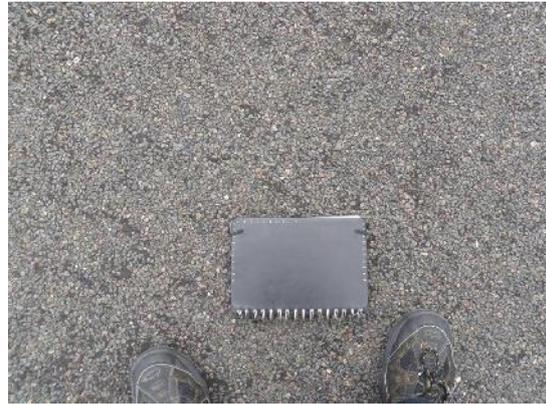
The runway surface consisted of a 7 mm sealed surface for about 100 m at each runway end and the remainder is a 15 mm asphalt surface. The end sections were sealed in about 1986, with the central asphalt constructed in about 2006.

Photo 2 – typical runway pavement – sealed section

Runway 11/29 should be resurfaced in about 5 years. It could be resurfaced with a bitumen seal containing at least 10 mm aggregate.

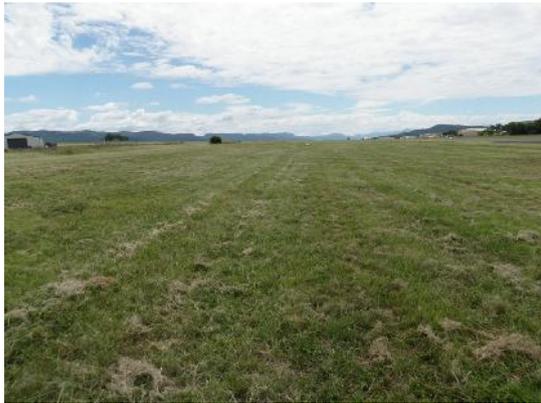
The graded area of the runway strip area had been mown regularly and provided a comfortable ride at about 65 kph.

Photo 3 – typical runway strip

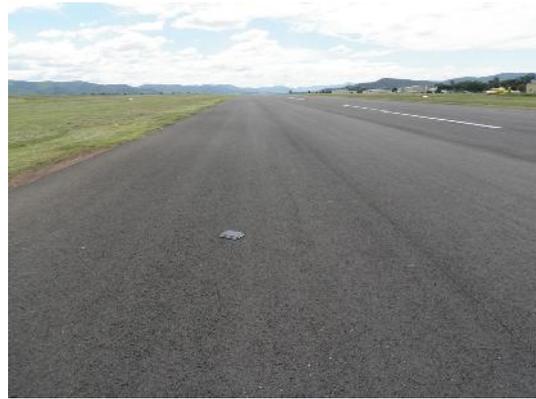
There was some minor rutting in the asphalt about 300 m from the RWY 29 Threshold, about 10 m south of the centreline. This has been caused by overloading of the pavement with a tandem wheeled vehicle; it does not appear to have been caused by an aircraft. There was no cracking evident with the rutting, which suggests that it may even have been caused during construction; it is of no immediate concern.

Photo 4 – general view of asphalt pavement with wheel ruts 300 m from RWY 29 threshold

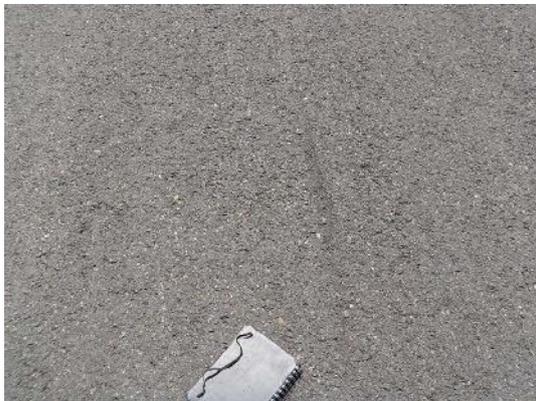
Photo 5 – typical asphalt pavement

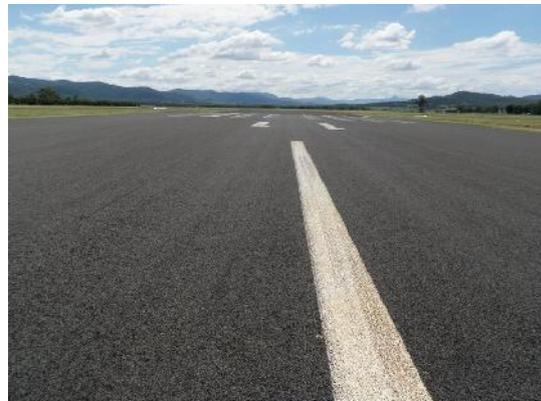
Photo 6 – Runway 11 threshold area

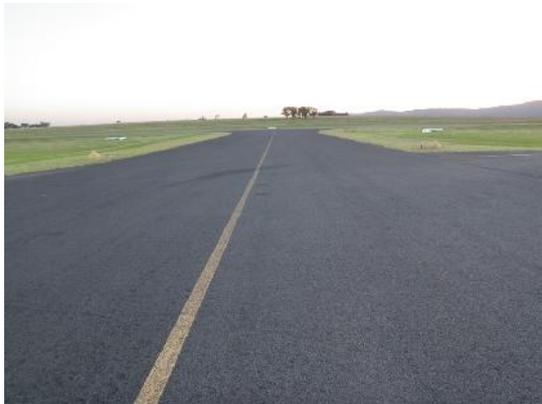
The main taxiway provides access to the apron area from runway 11/29. It is 15 m wide. It has a bitumen seal surface that appears to be of a similar age as the runway ends. It was basically sound with minimal stone loss and minor cracking.

Photo 7 – Main taxiway

The main taxiway should be resurfaced in about 5 years. It could be resurfaced with a bitumen seal containing at least 10 mm aggregate.

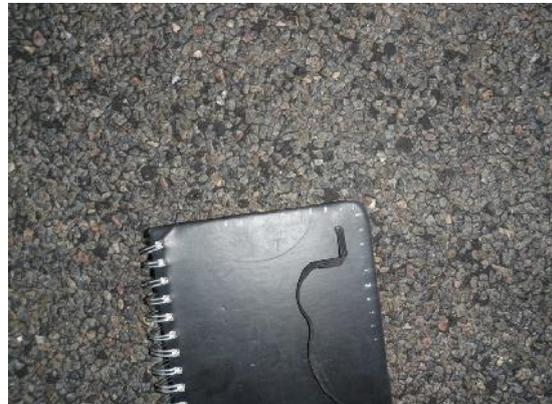
Photo 8 – Typical main taxiway pavement

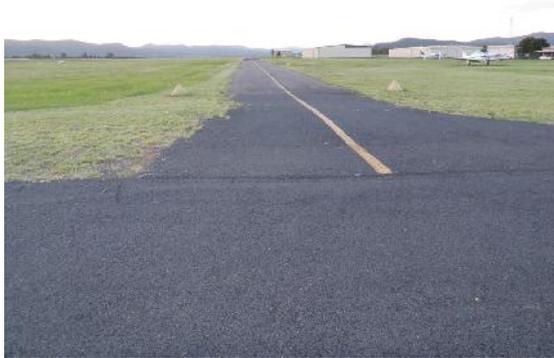
The pavement appears to have been installed in a hurried manner and its usage has grown over time and has overstressed the sub-standard pavement. The entire length is uneven and appears to be a risk to aircraft operations. There are significant surface cracks, about 10 to 15 mm wide, near the entrance to the hangars.

Photo 9 – Parallel taxiway

This taxiway needs to be reconstructed as soon as possible as it presents a hazard to the safe operation of aircraft. The reconstruction should also include widening the pavement to 7.5 m wide (MOS sub-section 6.3.1)

Recommendation 7 *The Code A taxiway parallel to the runway should be reconstructed with a final pavement width of 7.5 m. and a clearance from the centreline to any headwall of 11 m.*

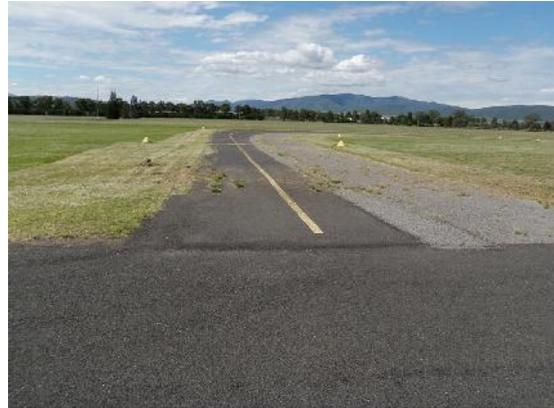
Photo 10 – Parallel taxiway/runway intersection

Parallel taxiway markings, at the entrance to runway 11 are incomplete due to pavement repairs and a partial gravel surface. The holding point area should be sealed and the marking reinstated.

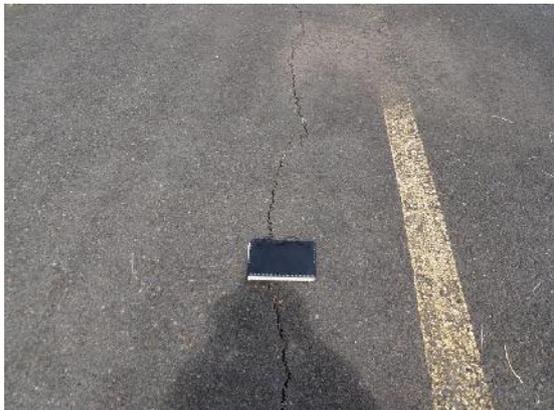
Photo 11 – surface cracking in parallel taxiway

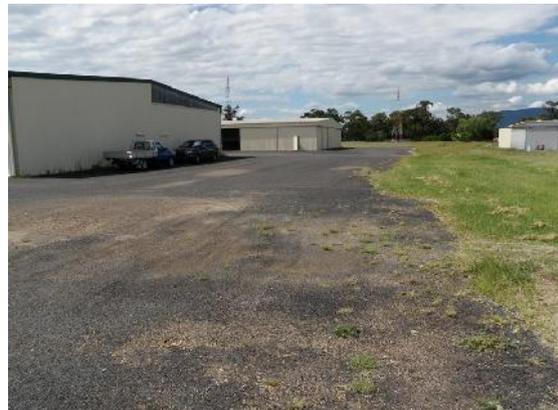
Photo 12 – entrance to hangar area

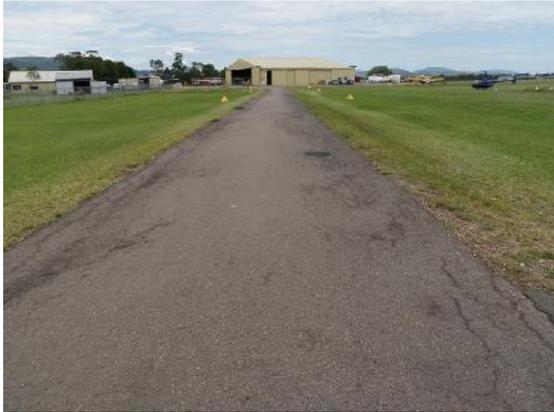
The taxiway is a 7.5 m wide grass taxiway with the central 4 m sealed; it is marked with yellow cones spaced 7.5 m apart.

Photo 13 – Pays taxiway

Recommendation 8 *Reseal Pays taxiway from the apron to Pays property, or restrict aircraft use.*

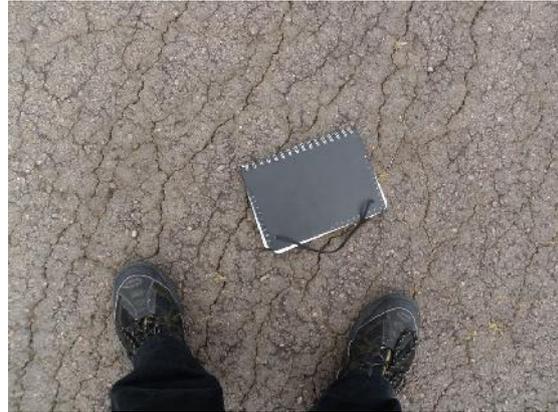
The seal surface is severely cracked, due to a combination of age (brittle) and overloading and has reached the end of its economic life. It's serviceability on an ongoing basis cannot be assured, and it may fail with the next pass of the fuel tanker; it is more likely to fail (form potholes) when the sub-surface becomes wet.

Photo 14 – surface of Pays taxiway

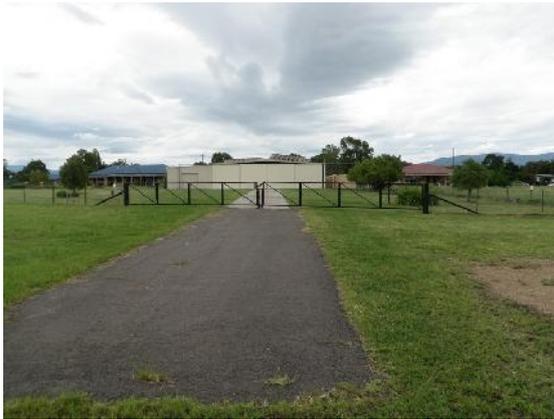
The two private access taxiways that access the threshold area of runway 29 were in reasonable condition. They were provided by and are maintained by the owners of the neighbouring properties. A representative of Neva-Part Aviation Welding was observed mowing the taxiway without a rotating beacon or high visibility clothing, or without any co-ordination with the ARO.

Photo 15 – Private taxiway to neighbouring property

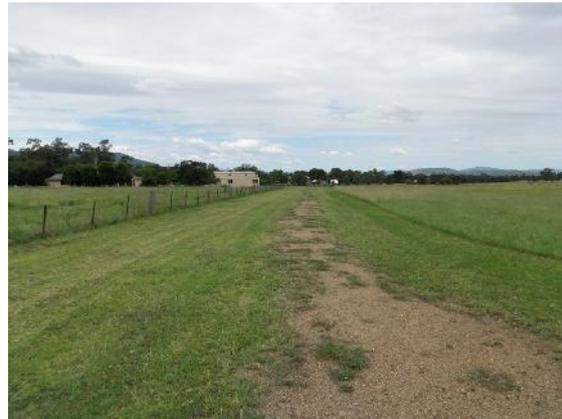
The Neva-Part Aviation Welding taxiway does not meet the clearance requirements for a taxiway as it is parallel to a fence located approximately 5.5 m from the centreline. The MOS sub-section 6.3.1 requires an obstacle free taxiway strip width of 16.25 m either side of the centreline. It may not be possible to meet this clearance requirement as the gateway to Neva-Part Aviation Welding is located in the corner of two fences. An alternative to minimise Council's risk exposure may be to sign it as not being available to aircraft under power.

Photo 16 – taxiway to Neva-Part Aviation Welding. Note fence line and an absence of taxiway markers

This natural surface taxiway should also have yellow taxiway markers defining its limits (refer MOS sub-section 8.2.4).

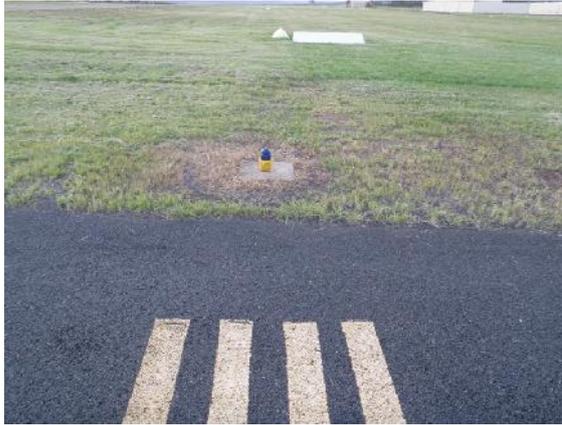
-) Pilot Activated Lighting Control system was not functioning and there was no NOTAM. The lights are activated by a Photoelectric cell and operate all night;
-) The holding point lights (main taxiway) were blue instead of the required amber/yellow, with one of the lights having a blown globe;
-) Blue taxiway and white runway light lenses had been intermixed at the taxiway intersection;
-) One runway light and two blue turning node lights were unserviceable; and
-) 3 lights in the runway 29 threshold lights were unserviceable as there luminance was not consistent with the other lights. This should have rendered the runway 29 threshold as unserviceable at night.

Photo 17 – Blue holding point light

During and subsequent to the inspection these faults were rectified, however they should not have existed as they were generally easy to fix (replacing lenses and lamps). NOTAM C2/16 was issued to advise of the PAL failure.

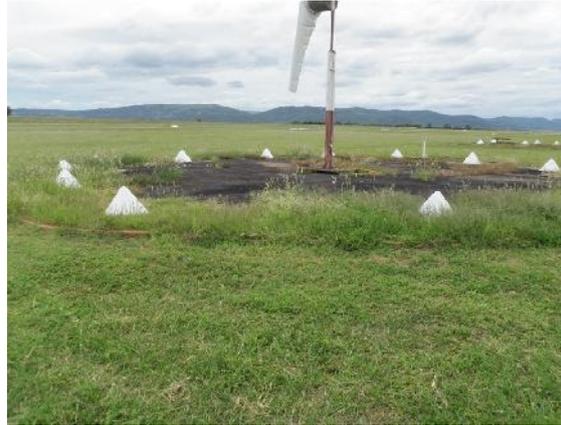
Photo 17 – Primary Wind Indicator

The Primary Wind Direction Indicator is located adjacent to the main apron and is serviceable. It has a black circle surrounded by 14 white cones.

The black circle required poisoning to remove the vegetation growing in it.
